Evaluation of Lightweight Concrete Performance in 55 to 80 Year Old Ships

By: R.D. Sturm, N. McAskill, R.G. Burg, and D.R. Morgan

Synopsis: Ten concrete ships currently being used as a floating breakwater around the log pond at the Pacific Paper Powell River plant in British Columbia, Canada, are after approximately 55 to 80 years of marine exposure, showing varying degrees of deterioration. The ships were constructed with a double mat of reinforcing steel and expanded lightweight shale aggregate concrete. Two separate inspections were conducted over the last seven years to evaluate the conditions of the hulls, decks, and other components of five of the ships. Cores taken from various portions of the ships with different exposure conditions were subjected to laboratory analysis and testing, including testing for compressive strength and petrographic examination. Results of these tests indicate that the lightweight aggregate concrete that the ships are constructed of has performed well, considering the harsh marine environment to which they are exposed. All the ships exhibited evidence of spalling induced by the corrosion of embedded steel reinforcement. However, the extent and se

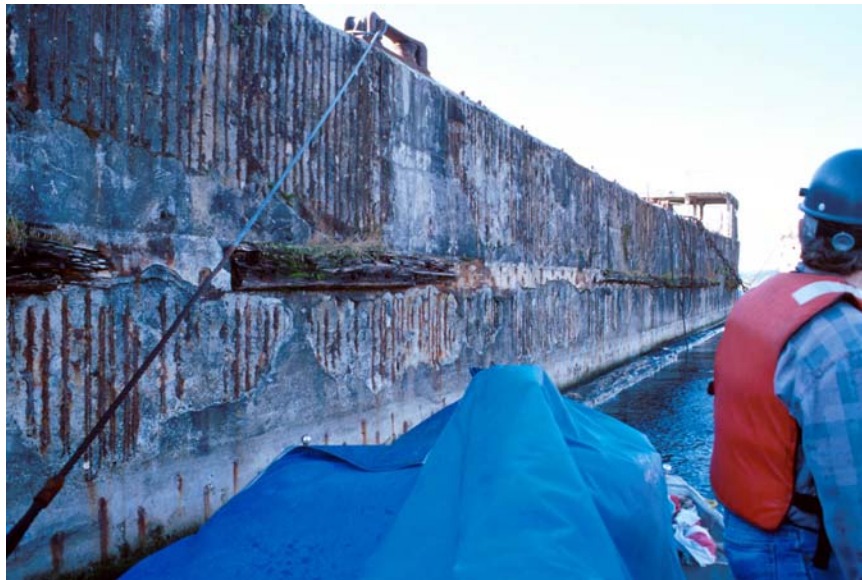
Overall, the inspection revealed the ships to be in generally good condition considering the minimal maintenance and harsh environment in which they are kept. Currently the ships exhibit varying degrees of deterioration mostly related to spalling of concrete cover over corroded steel reinforcement (Fig. 3). The hull of several of the ships exhibits numerous diagonal structural cracks, particularly apparent near the bow and stern thirds of the ships. Such cracks likely formed from cyclic loading and stressing of the ship. The bows and sterns of the ships also exhibit damage reportedly caused by incidental impact with the other ships during storms. This structural cracking and damage has allowed air, moisture, and sea salts to locally penetrate to the level of embedded reinforcement, promoting corrosion of the steel bars and subsequent spalling of the concrete cover. Deterioration on the *Emile Vidal* has also been accelerated by exposure of the concrete to stored salts in the holds. It is important to note, however, that with exception of the *Peralta* and *Emile Vidal*, and despite having cover of approximately 7/8", far less than current ACI 318 requirements, most of the hulls on the majority of the ships are not extensively spalled, particularly on the more protected, leeward side.

Fig. 3 Severe spalling along the hull of the *Emile Vidal* exposes corroded steel reinforcement. Most of the surface distress on the other ships built in the 1940's is not so severe.

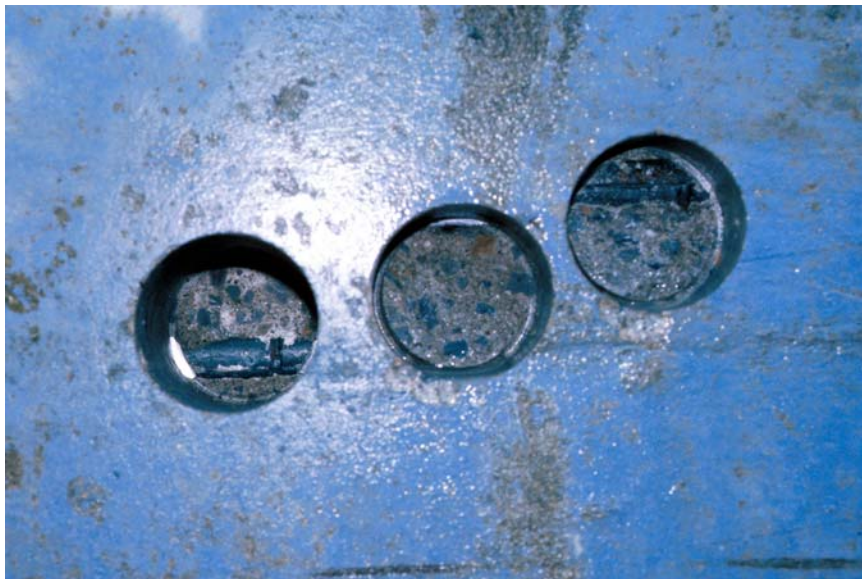
Removal of loosely attached, partially spalled surface concrete typically exposed the outer mat of steel reinforcing bars. The outer face of these exposed bars exhibits mild to severe corrosion of the steel. However, the backsides of many of these bars, exposed during coring, exhibit only mild to negligible corrosion (Fig. 4). Cores taken through several of the diagonal cracks on the hull of the *Armand Concidere* and *Yogn* also revealed only minor to negligible corrosion of steel reinforcing bars intersected by these cracks (Fig. 5). Overall, most inspected sections of embedded steel bars exposed by coring in sound areas of concrete show mostly minor to negligible corrosion of the steel bars.

Fig. 4 Photograph shows steel reinforcing bars exposed by coring along the hull of the *Yogn* are in good condition with negligible corrosion.

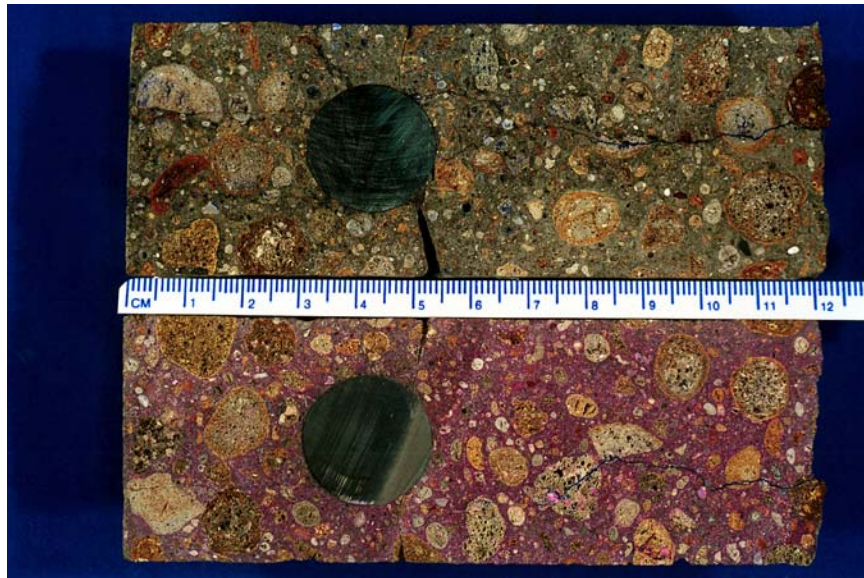
Fig. 5 Longitudinally cross sections of a core drilled over a diagonal crack along the hull of the *Armand Concidere* shows no corrosion of steel and minimal carbonation of paste. The lower section was treated with phenolphthalein.

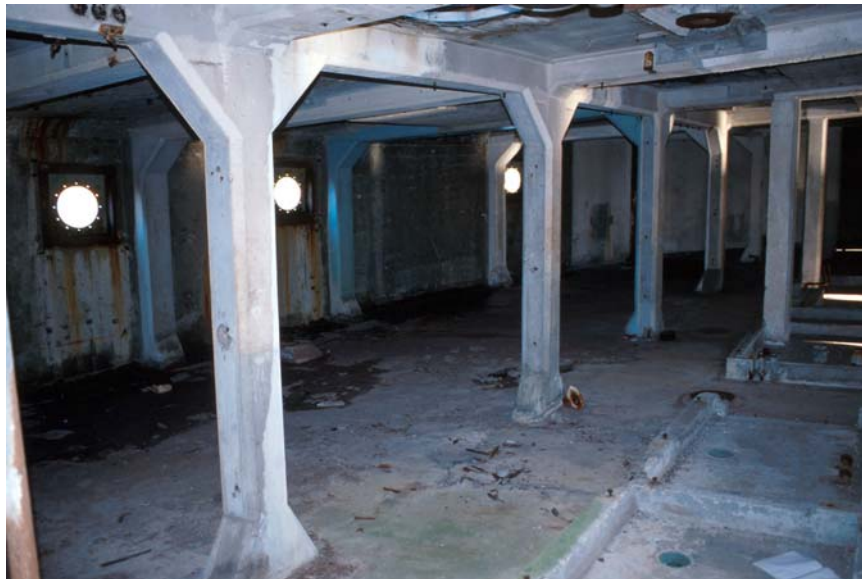
Fig. 6 View of the interior of a cabin on the *Emile Vidal* shows minimal deterioration of surfaces protected from rain and seawater.

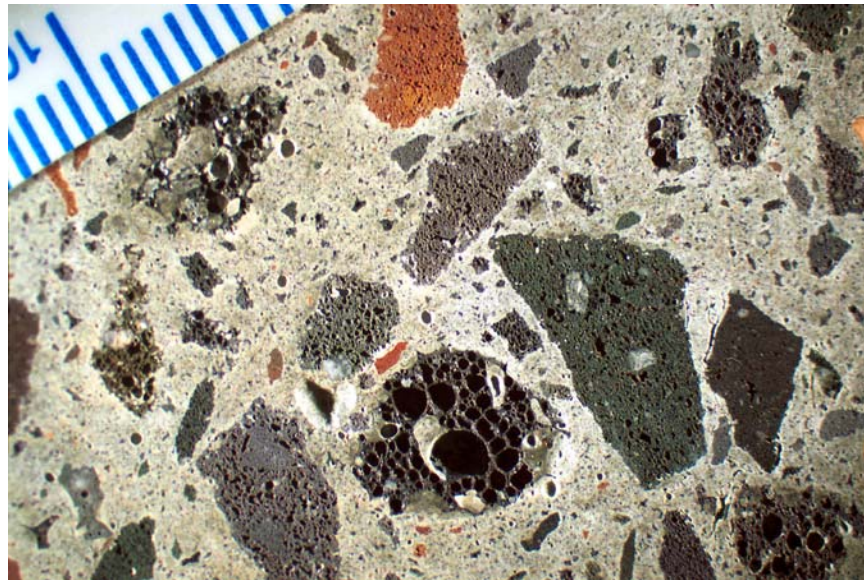
The concrete used in the construction of the *Peralta* contains black to dark brown, partially crushed, expanded shale aggregate, 6 to 10 mm (1/4 to 3/8 in.) top size, uniformly dispersed in a non-air-entrained portland cement matrix (Fig. 7). No natural rock or sand was observed in the concrete samples taken from this ship. The vesicular lightweight aggregate is mostly angular to subangular and highly porous with pore sizes ranging up to 1 mm. The lightweight fines are angular fragments of the manufactured aggregate and include some small, glassy particles exhibiting few visible voids.

Fig. 7 Finely-ground cross section of a concrete sample taken from the *Peralta* shows the appearance of the manufactured lightweight aggregate and good condition of the cement matrix. Millimeter scale shown.

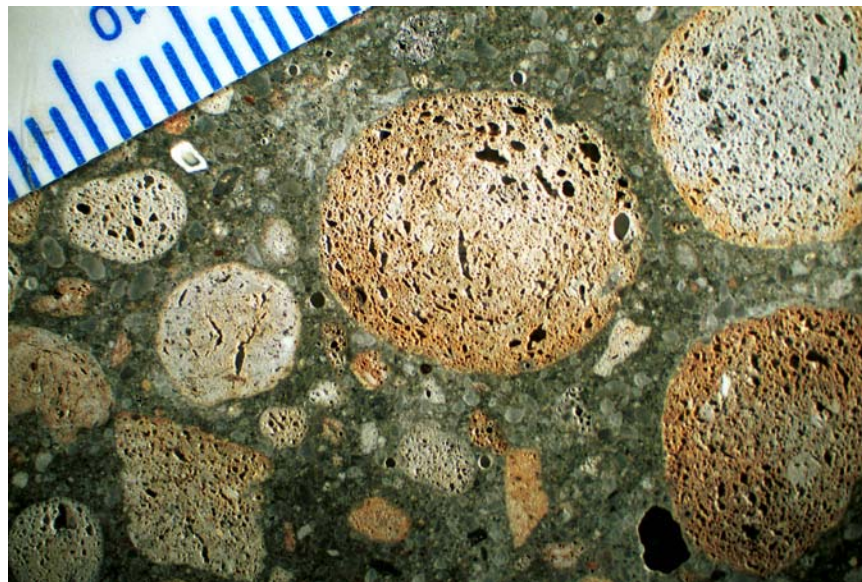
The concrete used in the construction of the *Emile Vidal*, and *Armand Concidere* are similar in appearance and general composition. Each consists of a light brown to light gray expanded shale or clay aggregate, 13 mm (1/2 in.) top size, and siliceous sand uniformly dispersed in a non-air-entrained portland cement matrix (Fig. 8). The lightweight aggregates are rounded to subangular, vesicular, and highly porous. Few manufactured aggregates of low porosity are noted. The nor-

Fig. 8 Finely-ground cross section of a concrete sample taken from the *Armand Concidere* shows the appearance and condition of the cement paste and manufactured aggregate. Millimeter scale.

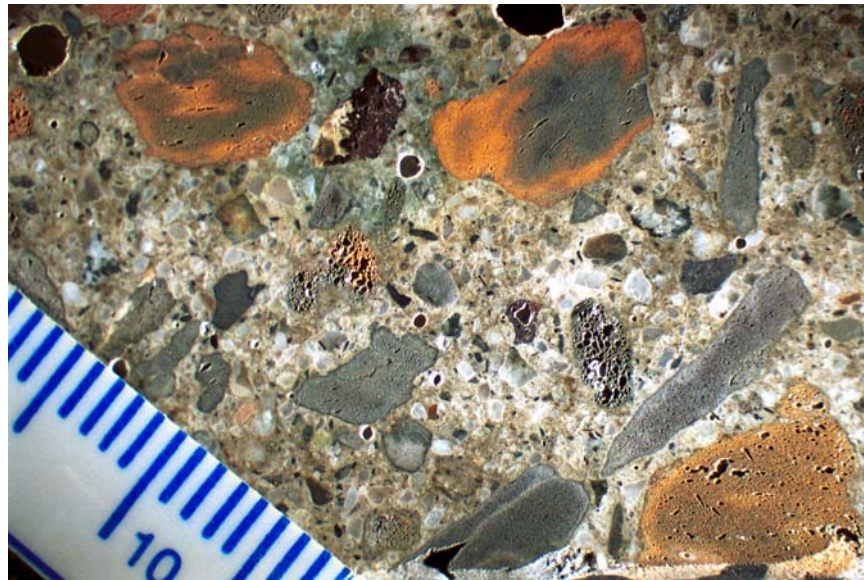
Cores taken from the *Yogn* (Fig. 9) contain lightweight, expanded shale coarse aggregate of nominal 10 mm (3/8 in.) top size that differs in appearance from that observed in the *Emile Vidal* and *Armand Concidere*. Otherwise, the concrete samples taken from the hulls of these ships exhibit similar siliceous, normal weight sand and similar micro-structural features in the cement paste.

Fig. 9 Finely-ground cross section of concrete taken from the *Yogn*. Lightweight coarse aggregate and natural sand were used in the concrete. Millimeter scale shown.

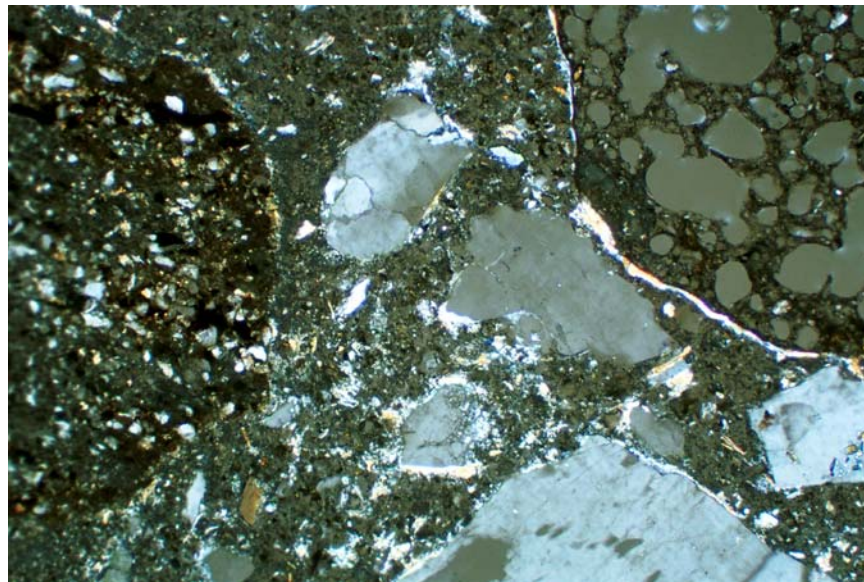
Microcracks are fairly scarce in the concrete samples taken from the 1940's ships. The minimal microcracking evident in the concrete could be attributed to similarities in elastic stiffness and other physical properties of the lightweight aggregate and the cement matrix (2, 6). Small gaps and tear-like features are noted in the cement paste and along the periphery of several aggregates. These features likely resulting from plastic deformation and settlement of the plastic concrete when the ships were constructed. It is interesting to note that most of these gaps and tears are filled with portlandite (Fig. 10) and the affected aggregates are well bonded to the cement paste. Some autogenous healing is also apparent in several older hairline cracks in the concrete.

Fig. 10 Thin section photomicrograph showing portlandite crystals filling gaps along the periphery of aggregates (marked with arrows) in concrete from the *Yogn*. Polarized light. Length of field = 1.3 mm.

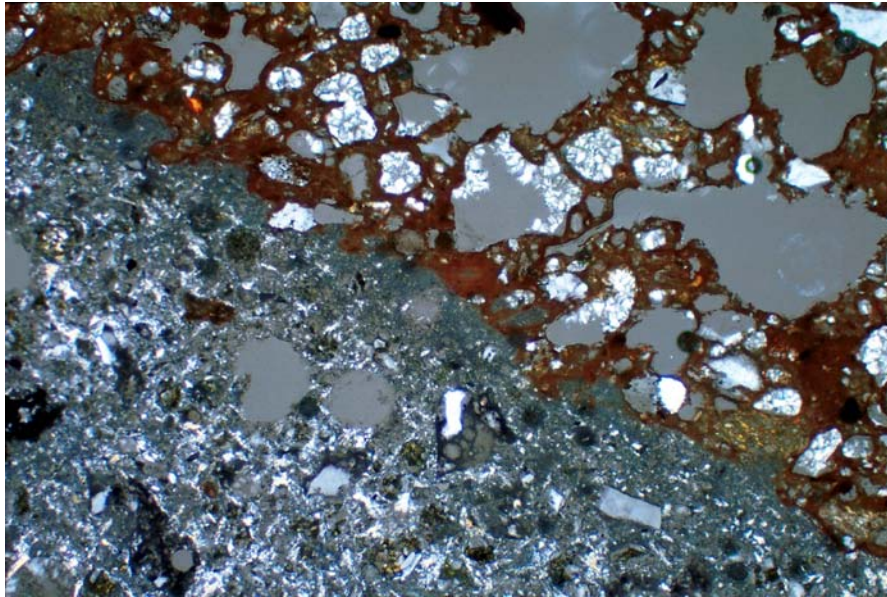
Peralta

Portions of the lightweight aggregate in the *Peralta* concrete exhibit evidence of a paste-aggregate reaction (Fig. 11). Apparent paste-aggregate reactions are also noted, but to a lesser degree, in several of the cores taken from the other ships. Similar reactions have been previously observed in other studies of lightweight concrete structures exposed to harsh conditions (7). Some of these reactions have produced reaction products, including minor amounts of a clear, amorphous reaction gel. These deposits are observed mostly within voids along the peripheral region of the porous manufactured aggregate. Paste adjacent to several of these lightweight aggregates appears to be cloudy when viewed in thin section, further attesting to reactions along the paste-aggregate interface. However there is very little evidence of disruption or cracking along the aggregate periphery and the aggregate is well bonded to the cement matrix. Many of the lightweight fines observed in the cores appear to have also undergone a reaction. Such paste-aggregate reactions are believed to be mostly pozzolanic in nature and tend to improve adhesion of cement paste to the lightweight aggregate. Occurrences of deleterious, expansive paste-aggregate reactions are scarce, and where they occur, are largely confined to the cement paste immediately surrounding the affected aggregate. Apparently, the internal restraint of the concrete and the availability of near surface pores in the vesicular aggregate are sufficient to accommodate such minor expansive reactions. The composition of the reaction gel may also be of a less expansive nature. Furthermore, the fines of the lightweight aggregate have also undergone a beneficial pozzolanic reaction similar in nature to some glassy mineral admixtures commonly used in many modern concretes.

Fig. 11 Thin section photomicrographs of concrete from the *Peralta* and *Armand Concidere* showing evidence of non-deleterious paste-aggregate reaction (marked between arrows). Polarized light. Length of each field = 1.3 mm.
