Chapter 8

Durability/Service Life of Structural Lightweight Concrete

Expanded Shale, Clay & Slate Institute (ESCSI)
2225 E. Murray Holladay Rd, Suite 102
Salt Lake City, Utah 84117
(801) 272-7070 Fax: (801) 272-3377
info@escsi.org www.escsi.org

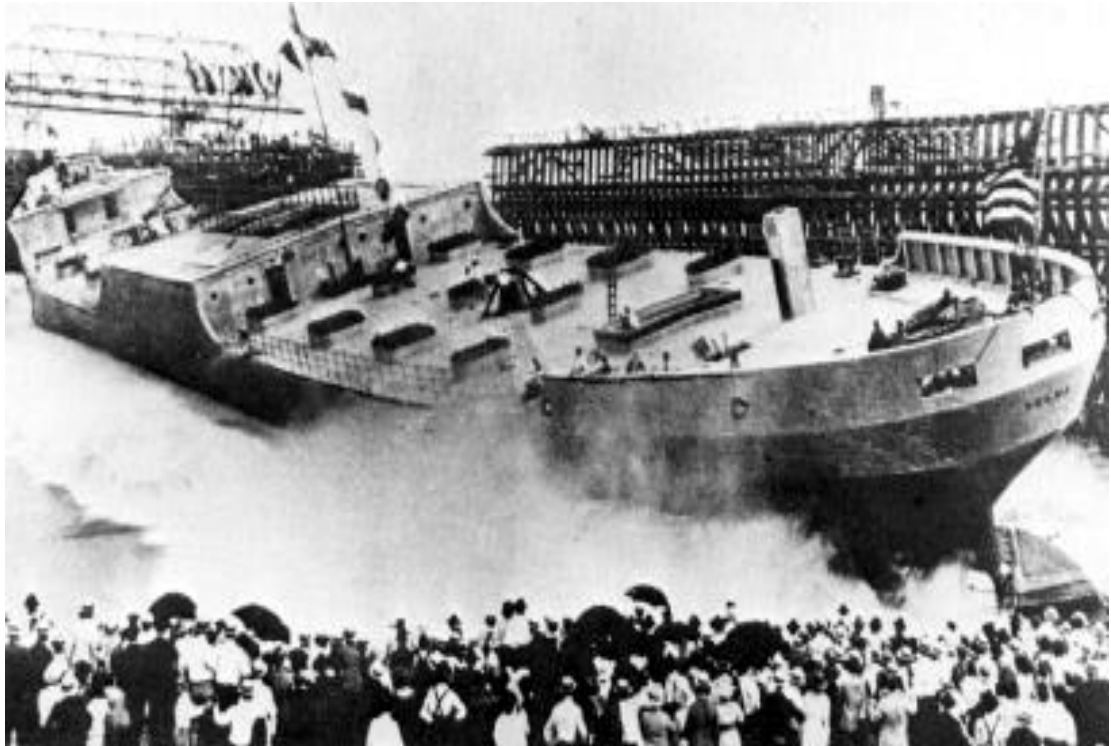
**Figure 8.1. *Launching of lightweight concrete ship
USS SELMA in 1919***

The first structural application using rotary kiln-produced lightweight concrete was the USS Selma, which was launched in 1919 (Holm 1980a). This 7,500 ton ship now partially submerged and resting on the ground in Galveston Harbor and declared a National Monument has been exposed to seawater continuously. In many areas it was damaged – when run onto a rock breakwater at Tampico Bay, Mexico, and as a result of hard berthing and extensive physical damage when the steel and equipment was salvaged from the ship. Much of the concrete below the waterline both inside and outside the hull (after the barnacles had been scraped off) appear to be in an as-cast condition with the form marks still visible.

Several of the Selma's holds contain water with over 6 ft. (2 m) head above the surrounding sea, providing ample proof of the low permeability of the concrete. In many undamaged sections of the ship the 0.5 to 1.2 in. (12 – to 30-mm) cover has proven surprisingly effective in protecting the reinforcing steel from

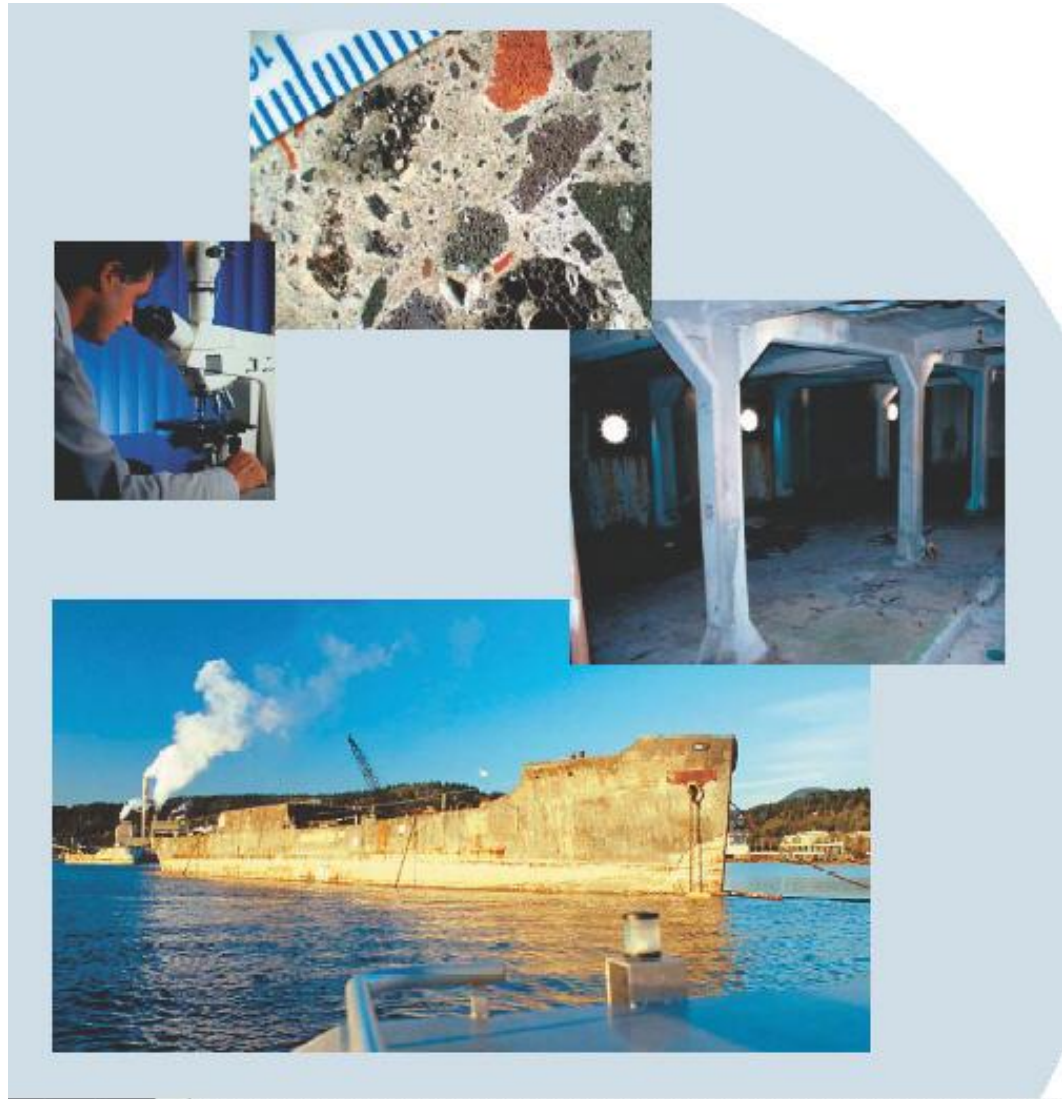
**Figure 8.2. *Powell River Ship,
Powell River, British Columbia, Canada***

Ten lightweight concrete ships are being used as a floating breakwater at the Pacific Paper Powell River Plant. Evaluation of the ships for long-term service durability of the lightweight concrete was recently conducted (Sturm, et. a. 1999). The ships range in age from 55 to 80 years with one ship constructed in the 1920's, and the other nine in the 1940's. These ships demonstrate the excellent performance of structural lightweight concrete after more than a half-century of marine exposure.

Petrography studies conducted at CTL (Construction Technology Laboratory) revealed limited microcracking, excellent aggregate/matrix contact zone,

complete hydration of the cement, and insignificant damage due to freezing and thawing. This microscopic examination clearly showed evidence of continued hydration and development of the cement matrix. This continued maturation of the concrete has contributed to the development of compressive strengths up to 8700 psi in the ships' hulls well beyond the minimum design strength (5000 psi) of the concrete. Concrete densities range from 106 lb/ft³ to 130 lb/ft³.

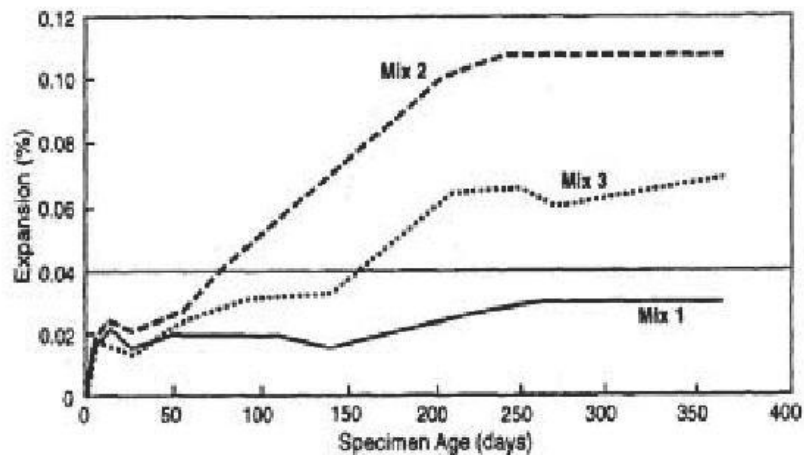
Figure 8.3. Reduction of expansion when lightweight aggregates are used (Bremner et al. 1998) (Mixture 1 – Nonreactive normalweight fine and coarse aggregate; Mixture 2 – Reactive normalweight aggregate and nonreactive fine aggregate; Mixture 3 – Reactive normalweight coarse aggregate and one half of absolute volume of nonreactive fine aggregate replaced by lightweight fine aggregate)

Concrete made from either natural lightweight aggregate or manufactured lightweight aggregate appears not to be adversely affected by any long-term interaction between silica-rich aggregates and the alkalis in the cement, or from the ingress of alkalis from natural sources such as seawater (Holm 1980a). In concrete mixtures that contain reactive normalweight aggregate, replacement of either reactive or even the nonreactive normalweight aggregate with lightweight aggregate has been found to significantly reduce deleterious expansions (Bremner et al. 1998, Boyd 1998) Figure 8.3.

The heating of the aggregate in a rotary kiln tends to activate the aggregate surface such that it appears to act as a source of silica to react with the alkalis from the cement at an early age to counteract any potential long-term disruptive expansion (Boyd 1998) Figure 8.4. Another factor that enables a porous aggregate to reduce disruptive expansion is the availability of pores (space) within the expanded lightweight aggregate for reactive material to precipitate into, in a benign manner. “The glass phase of expanded clay, shale and slate may be alkali reactive but expansion of concrete from this cause has not been observed because any siliceous gels that are generated are accommodated within the abundant air-filled cavities that characterize the expanded particles,” ASTM C294 “*Standard Descriptive Nomenclature for Constituents of Concrete Aggregates*,” section 26.3.5. In Figure 8.3, the beneficial effect of replacing some of the aggregates with lightweight aggregates on expansion can be seen.

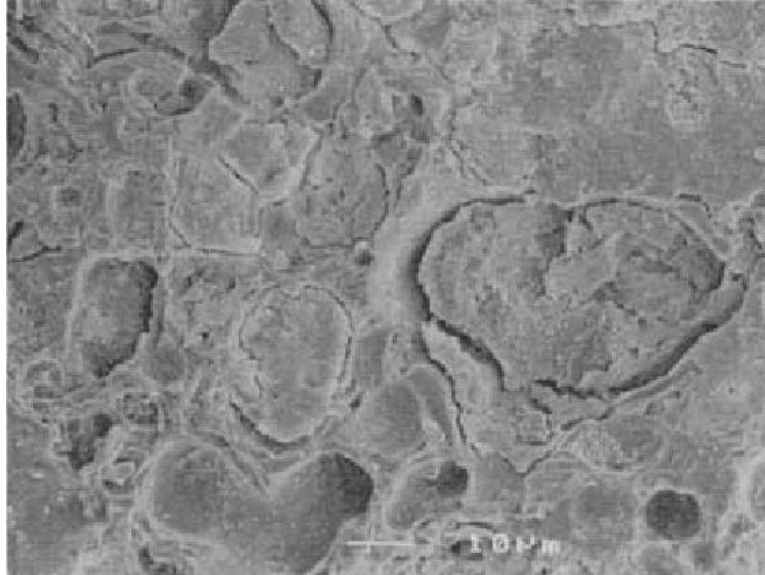
Figure 8.4. *Concrete with a precipitation of alkali-rich material in the pores of lightweight aggregate (Boyd 1998).*

In Figure 8.4, precipitation of alkali-rich material in the pores of an expanded aggregate can be seen in concrete made with a well-known reactive normalweight coarse aggregate in which some of the nonreactive fine aggregates have been replaced with lightweight fine aggregates.

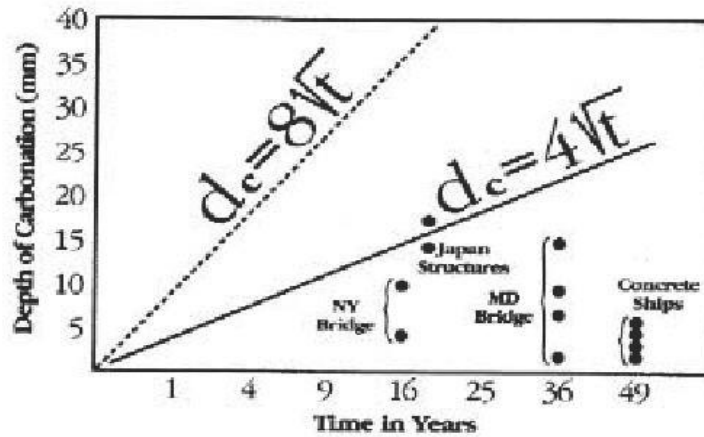
Figure 8.5. Measured depth of carbonation (in millimeters) of exposed lightweight concrete (from Holm, Bremner, and Vaysburd 1988)

The results of measurements of carbonation depths on mature marine structures in North America (shown in Fig. 8.5) are paralleled by data reported by Ohuchi et al. (1984). These investigators studied the chloride penetration depth of carbonation and incidence of microcracking in both structural lightweight concrete and normalweight concrete on the same bridges, aqueducts, and caissons after 19 years of exposure. The high-durability performance of those structures as measured by the test results of carbonation depths, microcracking, and chloride penetration profiles Ohuchi et al. (1984) are similar to reports by Khokrin (1973) who suggested that with regard to other variables (specimen size, media pressure, and equipment), structural lightweight concrete had equal or lower permeability than its normalweight counterpart. Khokrin (1973) further reported that the lower permeability of lightweight concrete was attributed to the elastic compatibility of the constituents and the enhanced bond between the coarse aggregate and the matrix. In the Onoda Cement Company tests (Nishi et al. 1980), concretes with water-cement ratios of 0.55, moist-cured for 28 days when tested at 9 kg/cm² water pressure had depth of penetration of carbonation 1.38 in (35 mm) for normalweight concrete and 0.95 in. (24 mm) for lightweight concrete. When tested with seawater, penetration was 0.59 and 0.47 in. (15 and 12 mm) for normalweight concrete and lightweight concrete, respectively. The author suggested that the reason for this behavior was “a layer of dense hardened cement paste surrounding the particles of artificial lightweight coarse aggregate”.

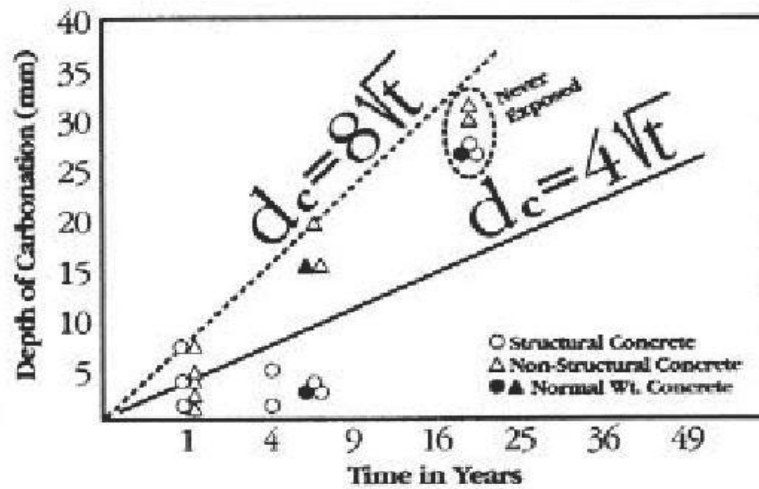
Figure 8.6. Measured depth of carbonation (in millimeters) of laboratory specimens of lightweight concrete (from Holm, Bremner, and Vaysburd 1988)

The effect of strength and density and moisture exposure on carbonation depth can be seen in Fig. 8.6 which covers specimens stored for over 20 years in a Richmond, VA., laboratory. These widely varying concrete types (normalweight, sanded lightweight, all lightweight and an insulating type concrete) had been part of an unrelated investigation into time related density and moisture variations in non-structural concrete. To develop fracture surfaces without saw cutting, the prisms were split by techniques similar to the tensile splitting method of ASTM C 496 as described earlier. The results clearly indicate that an increased rate of carbonation occurs in low strength concrete in a dry environment.

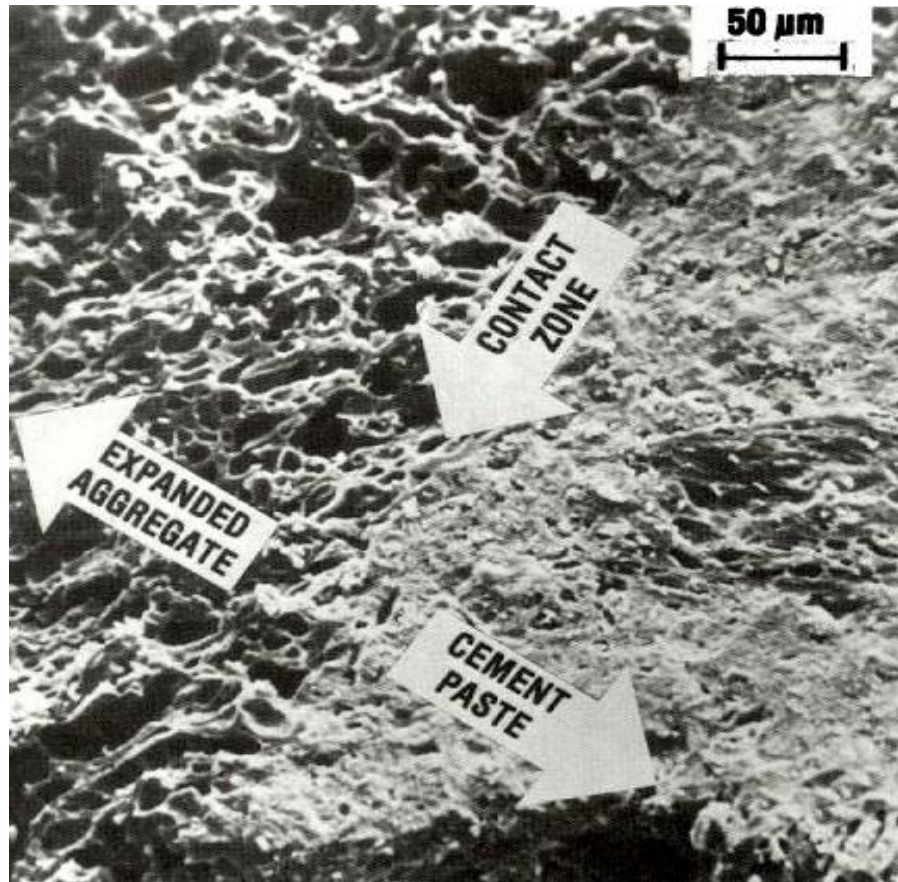
Figure 8.7. Paste-Aggregate Interface

Scanning electron microscope photograph of aggregate/matrix contact zone; from the cover of *“State-of-the-Art Report on High-Strength, High-Durability Structural Low-Density Concrete for Applications in Severe Marine Environments”*, by Thomas A. Holm and Theodore W. Bremner.

Micrographs of the contact zone of specimens were prepared for examination in a Cambridge S4-10 scanning electron microscope equipped with a Tracor Northern NS-880 energy dispersive X-ray analyzer. An example is Figure 8.7, which is a micrograph from the waterline of a more than 60-year-old concrete ship that was previously reported by Holm (1980a), and Holm, Bremner, and Newman (1984). Based on this micrograph and an examination of other areas, it would appear that a good bond develops between the lightweight aggregate and the mortar matrix.

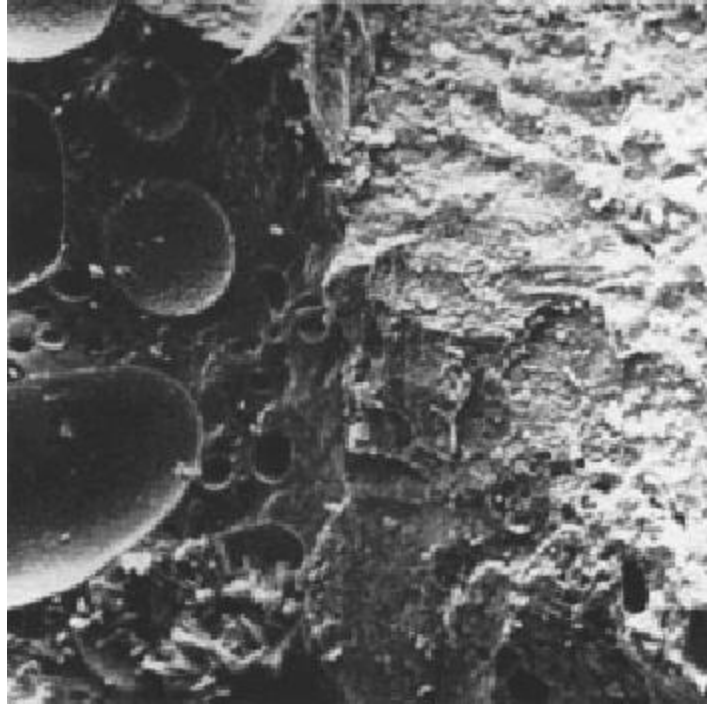
Figure 8.8. *Fractured surface of concrete from USS Selma. (Expanded aggregate is on the left, and the cement paste is on the right. Micrograph width is 550 μm) (from Bremner, Holm, and Morgan 1996)*

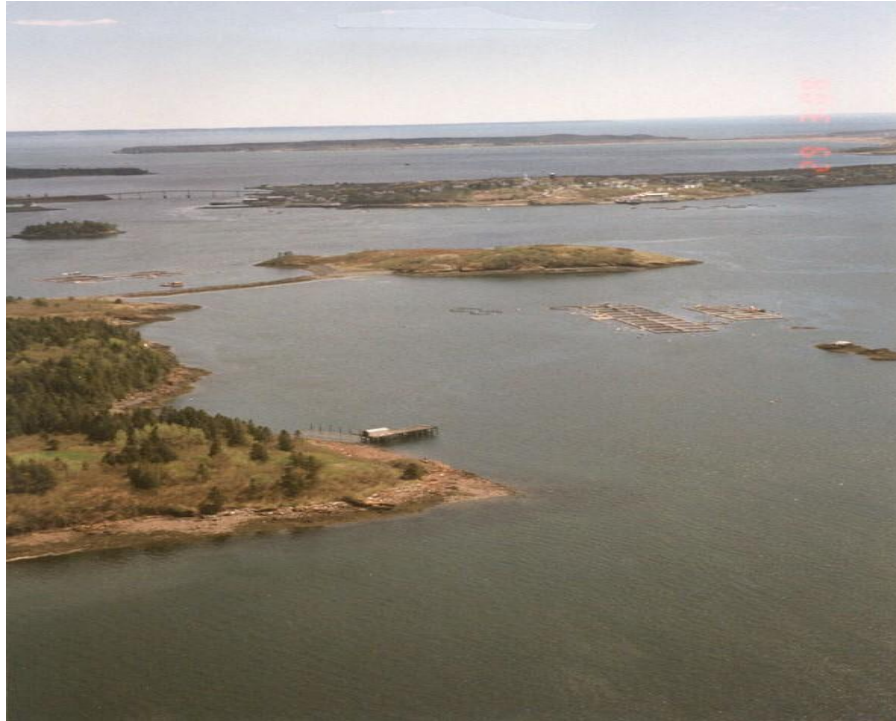
Figure 8.9. *Treat Island, Maine showing US Army Corps of Engineering Severe Weathering Station (Photo by R. Holm, 1998)*

Since 1980, Natural Resources Canada, through its Canadian Centre for Mineral and Energy Technology (CANMET), has installed numerous lightweight concrete prisms at the U.S. Army Corps of Engineers, Treat Island, Maine, exposure site. The specimens are prisms of dimensions 1 by 1 by 3 ft. (0.305 by 0.305 by 0.914 m). They are located on a wharf at mid-tide level so that they are subjected to twice-daily tidal cycles that result in over 100 cycles of freezing and thawing per year. All lightweight concrete specimens were air entrained.

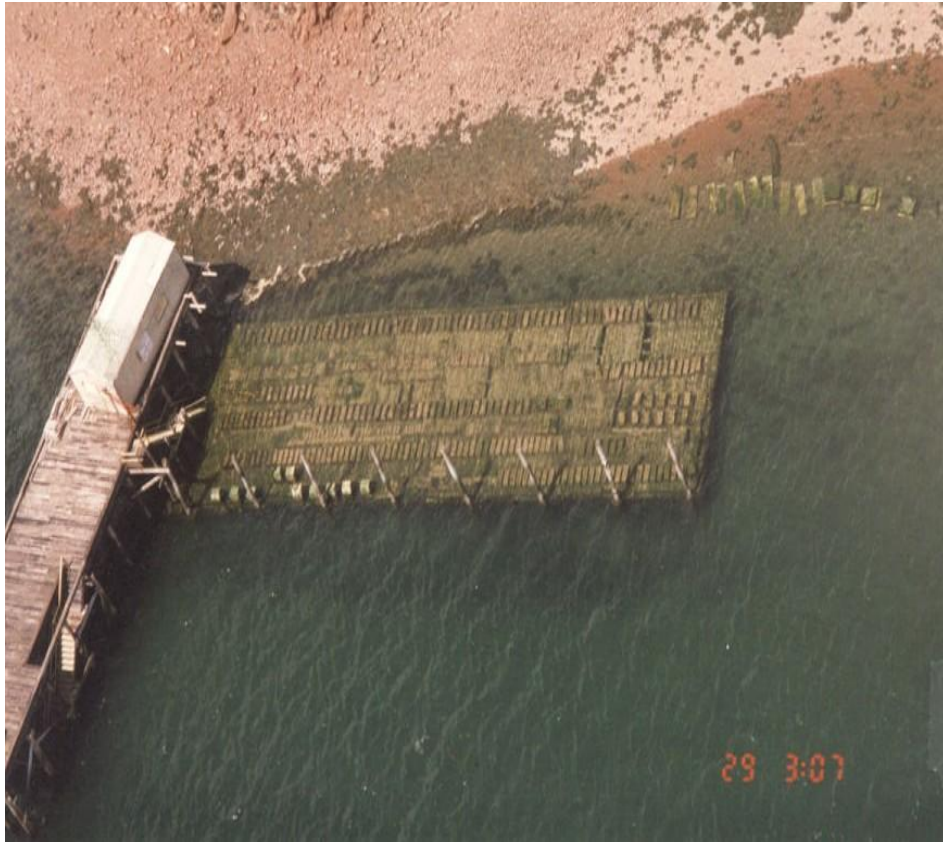
Figure 8.10 *Treat Island, Maine research center
Lightweight concrete specimens in bottom row. Exposed
To two tidal cycles per day (R. Holm, 1998)*

Structural lightweight concrete has been placed at Treat Island as part of five separate investigations starting in 1980 and also in 1985, 1986, 1988 and 1990. More than 70 specimens are situated in one long line on the dock as shown in Fig. 8.10 and are referenced as Phase III, VI, VII, X and XI in the “2004 Review of Programs Natural Weathering Exposure Station, Treat Island”, USA Corps of Engineers Report.

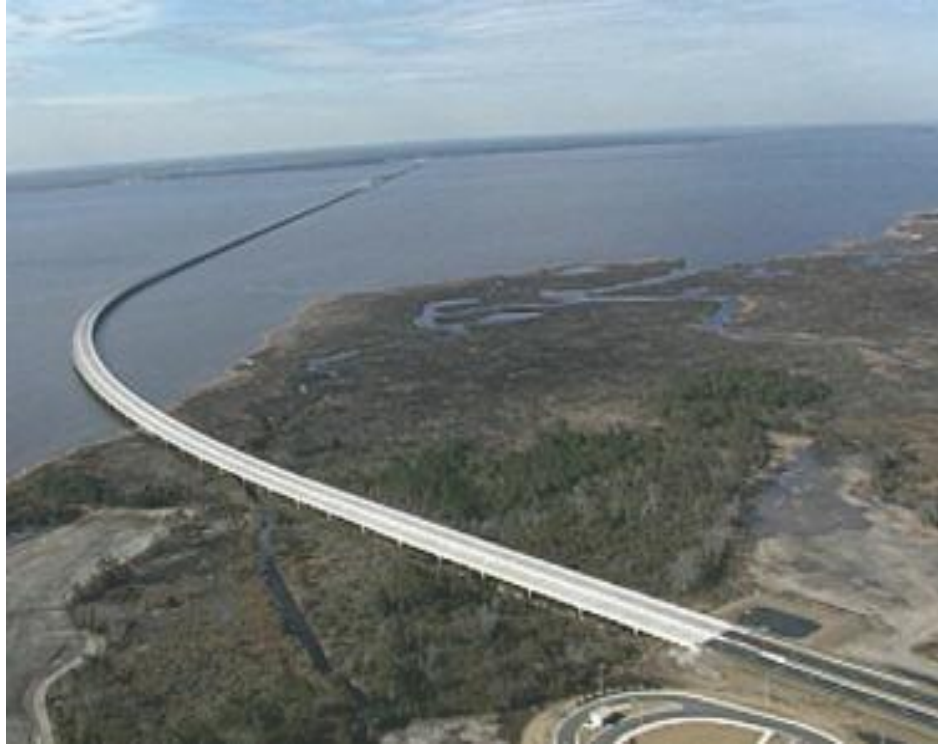
Figure 8.11. *The Virginia Dare Bridge spans the Croatan Sound From Manns Harbor to Roanoke Island, North Carolina.*

History was made in North Carolina on August 16, 2002 when a new bridge opened. (See Fig. 8.11). The Virginia Dare Bridge is the longest bridge in the Carolinas; at 5.3 miles, it is 2 miles longer than any bridge in the Carolinas, and one of the longest concrete bridges on the East Coast. This bridge is designed to last a century, twice as long as the preceding generation of bridges. In the summer of 1996 the State of North Carolina and the Department of Transportation determined that a new bridge was required to replace the existing bridge connecting the Dare County mainland with the hurricane-prone East Coast. Traffic volume is expected to more than double by 2020. The present bridge, opened to traffic in April 1957 and nearly 43 years old, is unable to handle that amount of traffic and already causes congestion for vacationers. It also increases the risks associated with evacuation in the event of a hurricane.

At a cost of \$91 million dollars, construction took a little more than 3.5 years and was completed in the summer of 2002. This is a pre-cast, pre-stressed concrete beam bridge with a cast-in-place lightweight concrete deck (riding surface). The logistics were challenging-each component had to be made on site or brought in by water or specially designed rail. Two concrete batch plants were needed-one was built in Manns Harbor, the other was built on a floating platform.
