Evaluation of Lightweight Concrete Performance in 55 to 80 Year Old Ships

By: R.D. Sturm, N. McAskill, R.G. Burg, and D.R. Morgan

Synopsis: Ten concrete ships currently being used as a floating breakwater around the log pond at the Pacific Paper Powell River plant in British Columbia, Canada, are after approximately 55 to 80 years of marine exposure, showing varying degrees of deterioration. The ships were constructed with a double mat of reinforcing steel and expanded lightweight shale aggregate concrete. Two separate inspections were conducted over the last seven years to evaluate the conditions of the hulls, decks, and other components of five of the ships. Cores taken from various portions of the ships with different exposure conditions were subjected to laboratory analysis and testing, including testing for compressive strength and petrographic examination. Results of these tests indicate that the lightweight aggregate concrete that the ships are constructed of has performed well, considering the harsh marine environment to which they are exposed. All the ships exhibited evidence of spalling induced by the corrosion of embedded steel reinforcement. However, the extent and se

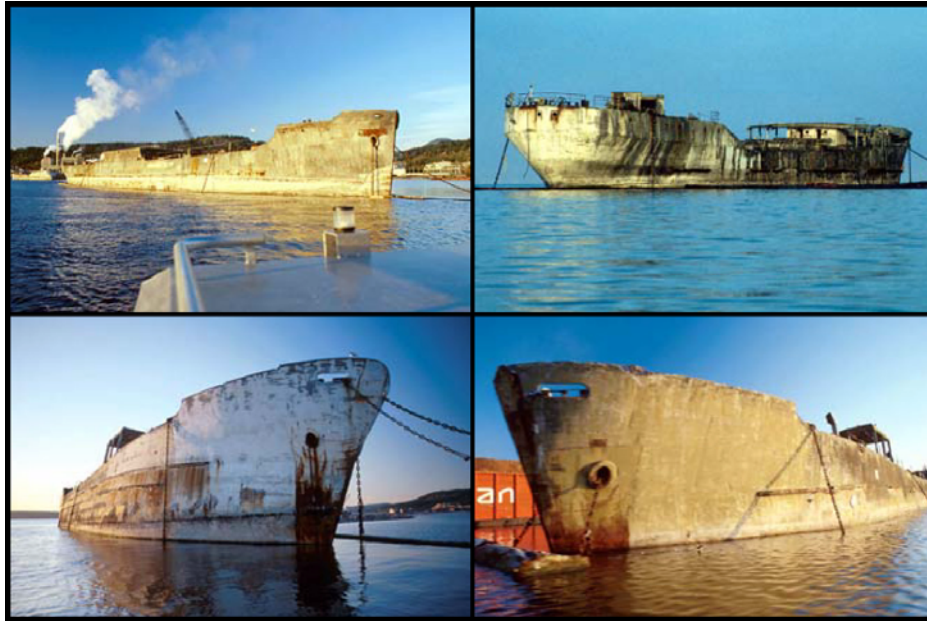
The second study of the Powell River ships was conducted in October 1998. Four of the ships, namely the *Peralta*, *Emile Vidal*, *Armand Concidere*, and *Yogn* (Fig. 2) were inspected and core samples were extracted from hulls, decks, and selected above-deck structures. The below deck, interior chambers of the ships were not directly inspected, however, some limited viewing of below-deck structures was made through hatches and other openings in the top deck. The general condition of the exterior of the ships, particularly the hulls, decks, and above-deck structures, was recorded and photo-documented. Cores were taken from selected hulls, decks, and hatches, as well as one column and one cabin wall. With the exception of one interior column, cores were taken from structures exposed to seawater or sea spray and rainwater. These cores were later subjected to petrographic examination, compressive strength testing, or both. This later inspection was conducted on behalf of the Expanded Shale, Clay and Slate Institute as part of an ongoing study of the durability of lightweight aggregate concrete exposed to a marine environment.

Fig. 2 Composite image of (clockwise from top left) the *Peralta*, *Emile Vidal*, *Armand Concidere*, and *Yogn*.
