WELLINGTON STADIUM

4,000 Precast Lightweight Concrete Components
Provide Seismic and Economic Solutions

The Wellington Stadium

New Zealand's First Use of High Strength Lightweight Precast Concrete

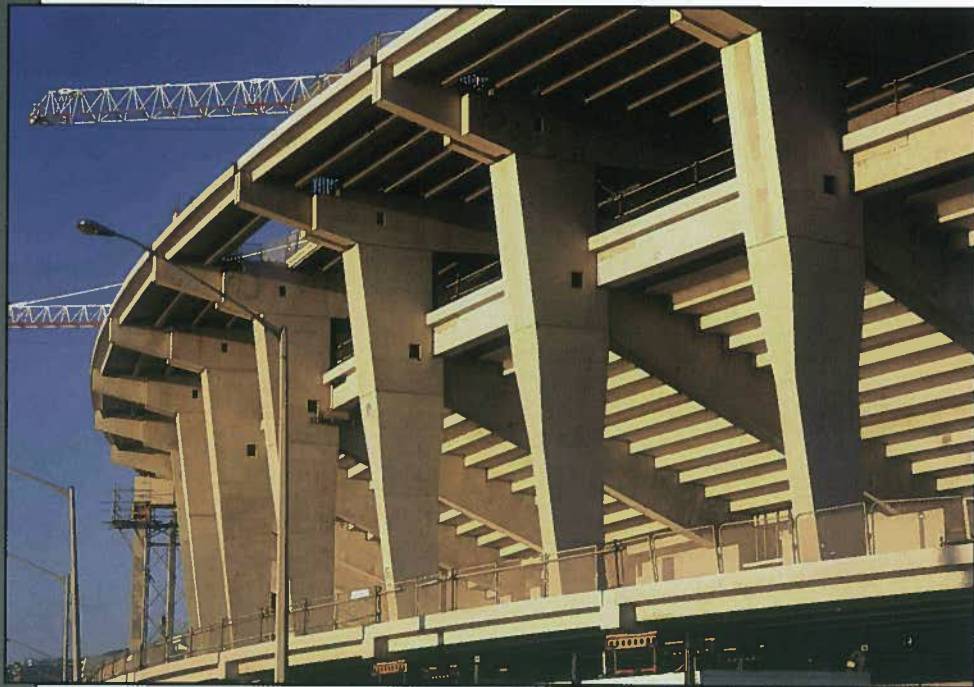
Exterior of 40,000-seat Wellington Stadium nearing completion

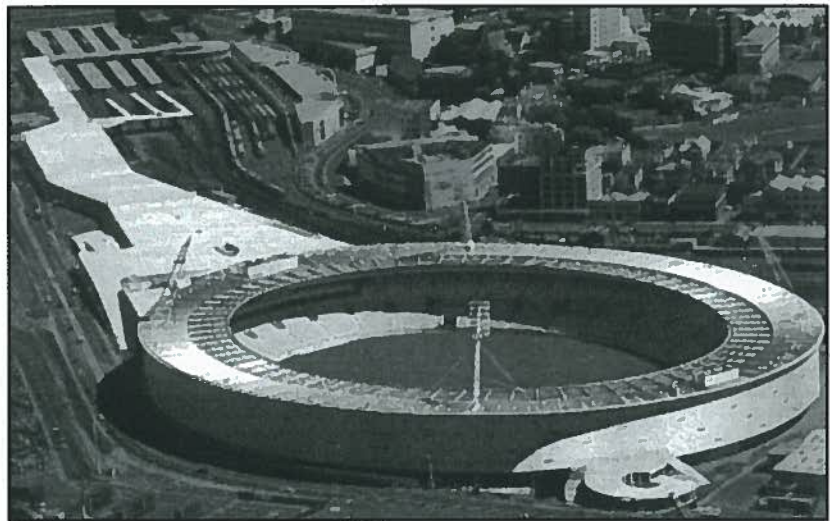
Figure 1 – The Completed Stadium

The structural layout consists of an oval bowl around the playing field (roofed only over the spectator seating) and is connected by a two-level open walkway and parking building to the railway station. At the southern end of the oval there is a four-storey administration building that also forms part of the main stand [Figure 1].
